Mothballing Historic Buildings

Sharon C. Park, AIA

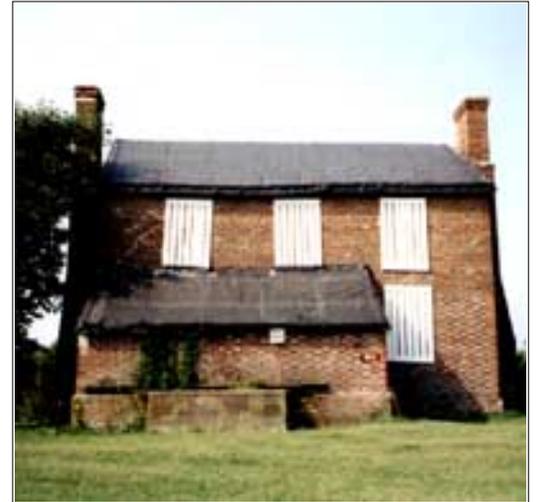
When all means of finding a productive use for a historic building have been exhausted or when funds are not currently available to put a deteriorating structure into a useable condition, it may be necessary to close up the building temporarily to protect it from the weather as well as to secure it from vandalism. This process, known as mothballing, can be a necessary and effective means of protecting the building while planning the property's future, or raising money for a preservation, rehabilitation or restoration project. If a vacant property has been declared unsafe by building officials, stabilization and mothballing may be the only way to protect it from demolition.

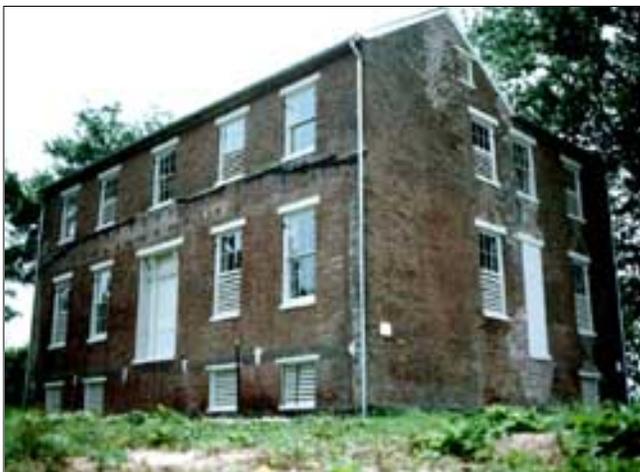
This building has been successfully mothballed for 10 years because the roof and walls were repaired and structurally stabilized, ventilation louvers added, and the property maintained. Photo: NPS files.

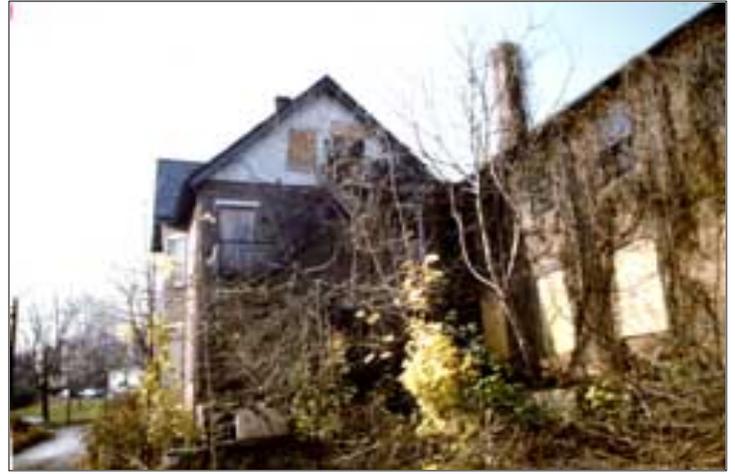
Boarding up without adequate ventilation and maintenance has accelerated deterioration of this property. Photo: NPS files.

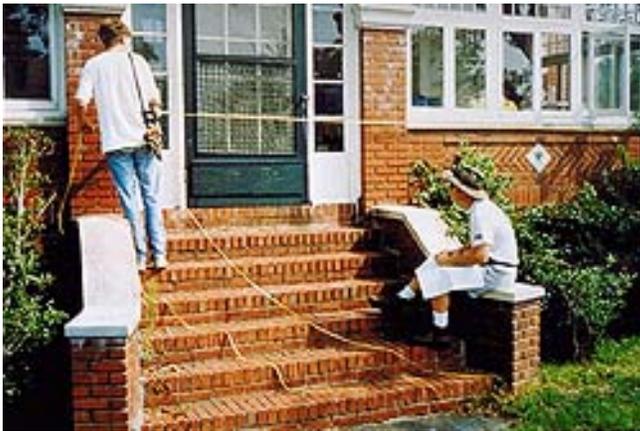
Documenting a building's history and assessing its condition provide information to set priorities for stabilization and repair, prior to mothballing. Photo: NPS files.

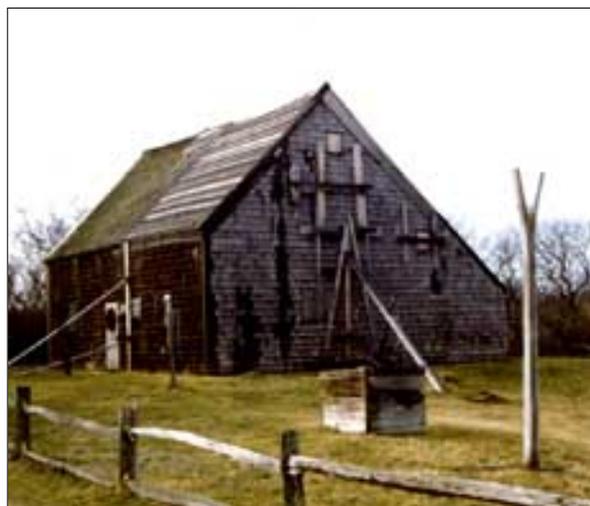
Buildings seriously damaged by storms or deterioration may need to be braced before architectural evaluations can be made. Photo: John Milner Architects. Photo: NPS files

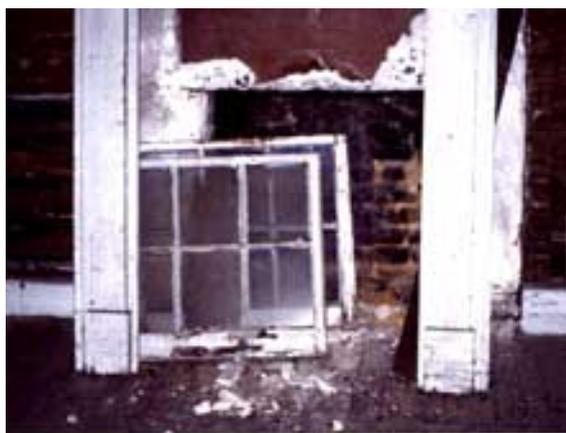
Loose or detached elements should be identified, tagged and stored, preferably on site. Photo: NPS files

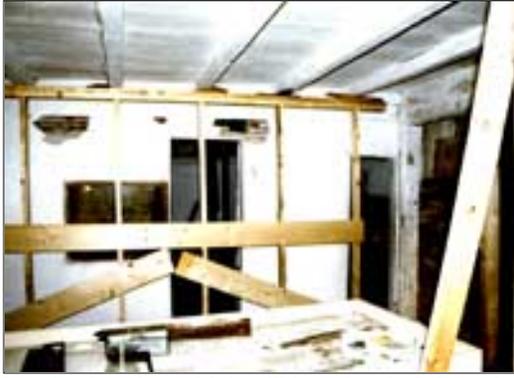
Interior bracing which will last the duration of the mothballing will protect weakened structural members. Photo: John Milner Architects.

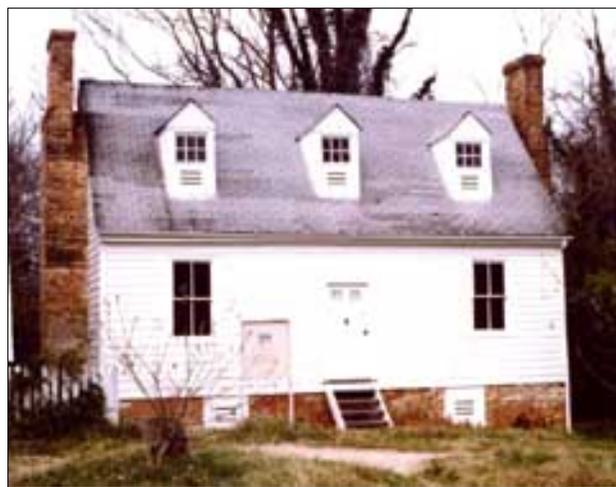
Regrading has protected this masonry foundation wall from excessive damp during its 10-year mothballing. Note the attic and basement vents, temporary stairs, and interpretive sign. Photo: NPS files.

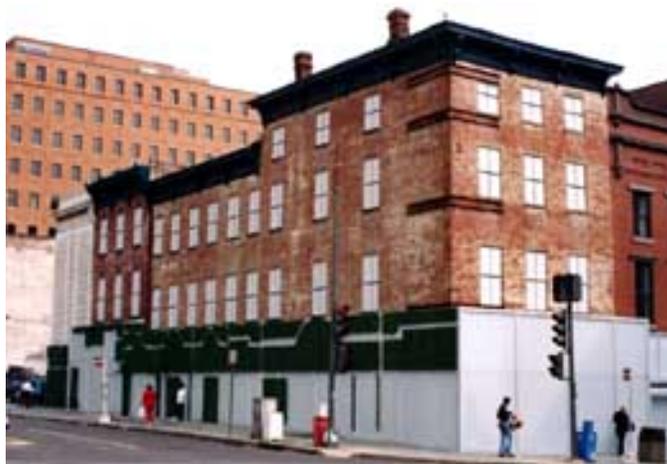
Urban buildings often need additional protection from unwanted entry and graffiti. This commercial building uses painted plywood panels to cover its glass storefronts. The upper windows on the street sides have been painted to resemble 19th century sash. Photo: NPS files.

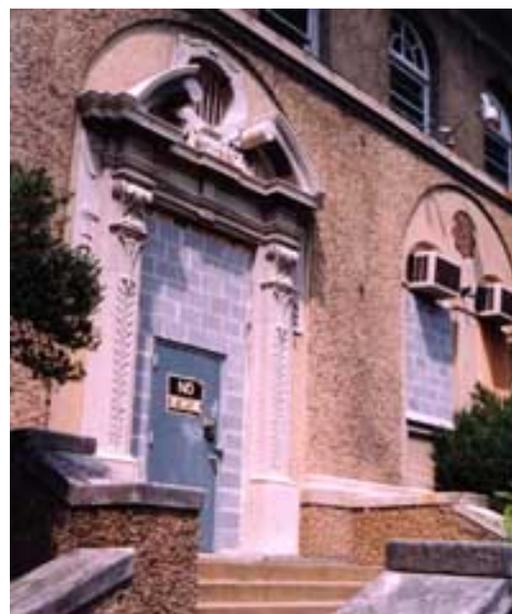
The first floor openings of this historic building have been filled with cinder blocks and the doors, window sash, and frames removed for safe keeping. The security metal door features heavy duty locks. Photo: NPS files.

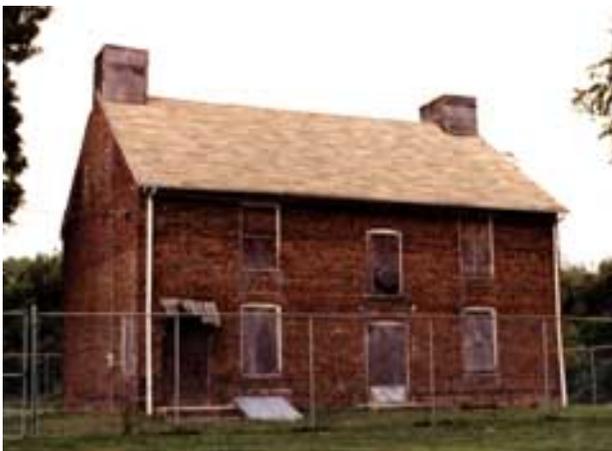
A view showing the exterior of the Brearley House, New Jersey, in its mothballed condition. Photo: Michael Mills, Ford Farewell Mills Gatsch, Architects.

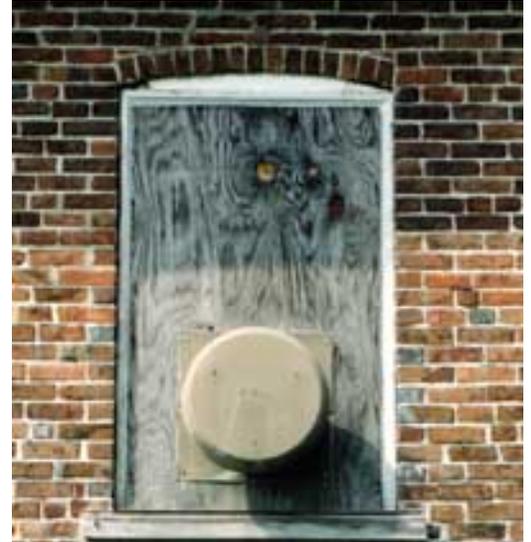
This exhaust fan has tamper-proof housing.
Photo: Michael Mills, Ford Farewell Mills
Gatsch, Architects.

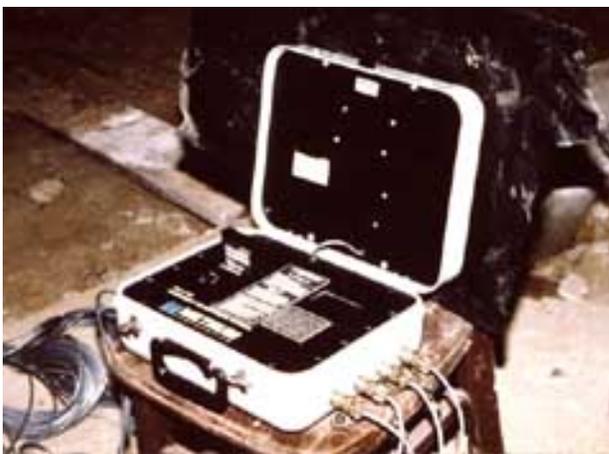
Portable monitors are used to record temperature and humidity conditions in historic buildings during mothballing. Photo: NPS files.
